NATMAP SURVEY BEACONS IN GOOD CONDITION

AFTER 46 YEARS

Canning Stock Route Traverse Survey Station Inspection Report 2010

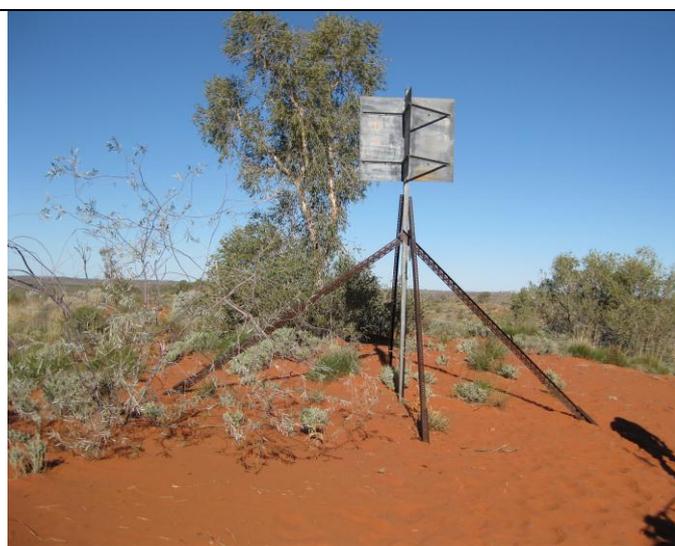
NM/F/198 (Courtesy L.McLean)

- **NM/F/198** was inspected at about 3:00pm (WST) on Friday 6 August 2010. Coordinates observed with the GPS unit held against the beacon centre pole were: 21 degrees 48.695 minutes South, 125 degrees 34.477 minutes East. **Map sheet used:** 1:250,000 NTMS: SF51-08 Percival, Edition 2. **Station Condition:** All structural elements were observed to be in good order ie metal vanes, centre pole and bracing struts. While the map indicated the track (so called Canning Stock Route) passed to the east of the station, in fact the main track was a hundred or so metres to the west with a secondary branch (probably for the curious) running off the main track on the southern side of the sandhill right to the base of the station and then rejoining main track on the northern side.

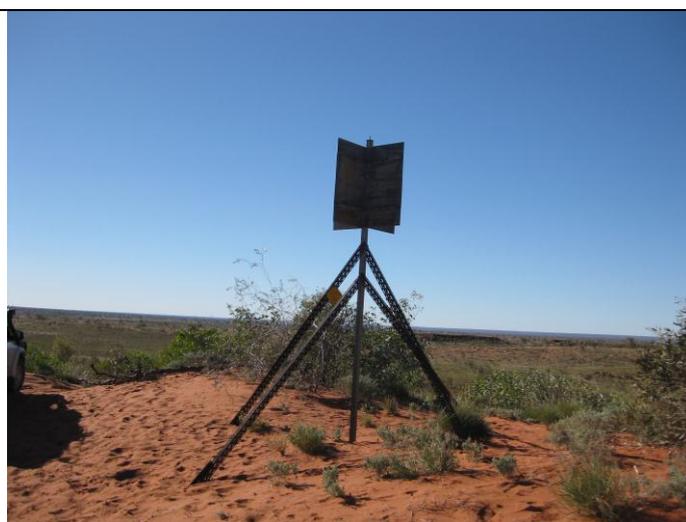
NM/F/199 (Courtesy L.McLean)

- **NM/F/199** was inspected at about 11:10am (WST) on Saturday 7 August 2010. Coordinates observed with the GPS unit held against the beacon centre pole were: 21 degrees 38.530 minutes South 125 degrees 45.975 minutes East. **Map sheet used:** 1:250,000 NTMS: SF51-08 Percival, Edition 2. **Station Condition:** All structural elements were observed to be in good order ie metal vanes, centre pole and bracing struts.

Although a prominent land mark, this station was not plotted on the map. Instead, the map plotted NM/F/2026 which was a recovery mark in the inter-dune valley to the north of the main station (beacon). The relationship between the two marks was not known until the station summary was obtained and examined after the stock route trip was over (attached at end of photos section). NM/F/2026 was neither sighted nor looked for. The decision to plot the recovery mark rather than the prominent land mark (beacon) seems curious from a vehicle traveller's perspective.

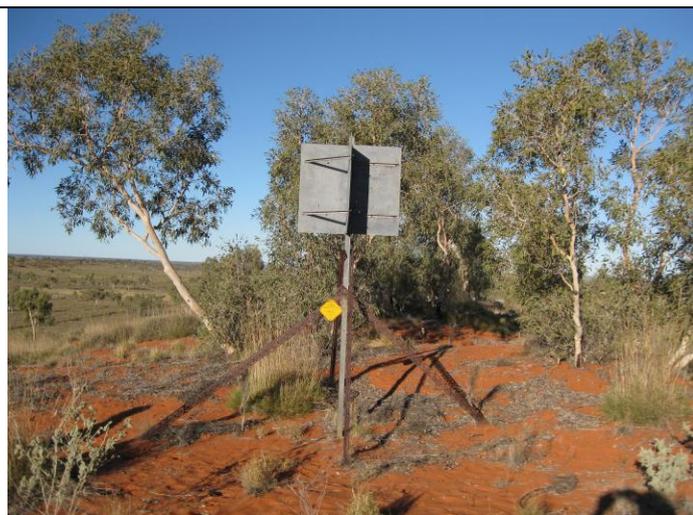
NM/F/201 (Courtesy L.McLean)

- **NM/F/201** was inspected at about 4:00pm (WST) on Saturday 7 August 2010. Coordinates observed with the GPS unit held against the beacon centre pole were: 21 degrees 23.101 minutes South 125 degrees 49.495 minutes East. **Map sheet used:** 1:250,000 NTMS: SF51-08 Percival, Edition 2. **Station Condition:** All structural elements were observed to be in good order ie metal vanes, centre pole and bracing struts. While the map indicates the track (so called Canning Stock Route) passes to the east of the station, in fact the main track was a couple of hundred metres or so to the west, a good bush camping site was located on the northern side of the sand hill on which this station was situated.

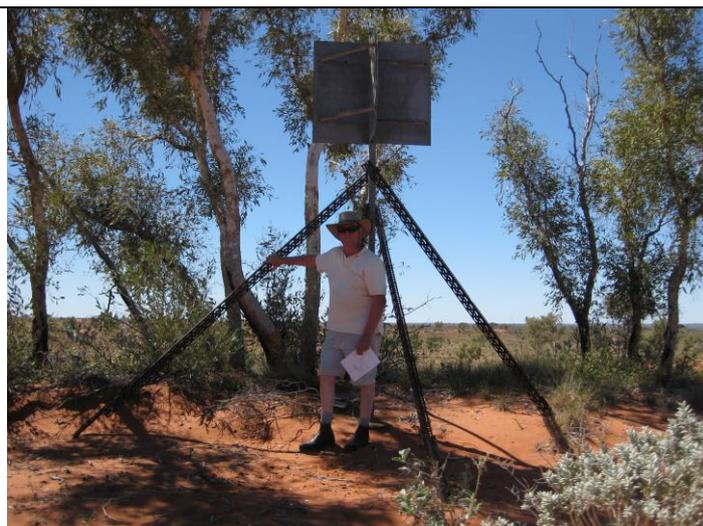
NM/F/203 (Courtesy L.McLean in picture)

- **NM/F/203** was inspected at about 11:30am (WST) on Sunday 8 August 2010. Coordinates observed with the GPS unit held against the beacon centre pole were: 21 degrees 11.921 minutes South 125 degrees 54.660 minutes East. **Map sheet used:** 1:250,000 NTMS: SF51-08 Percival, Edition 2. **Station Condition:** All structural elements were observed to be in good order ie metal vanes, centre pole and bracing struts. .

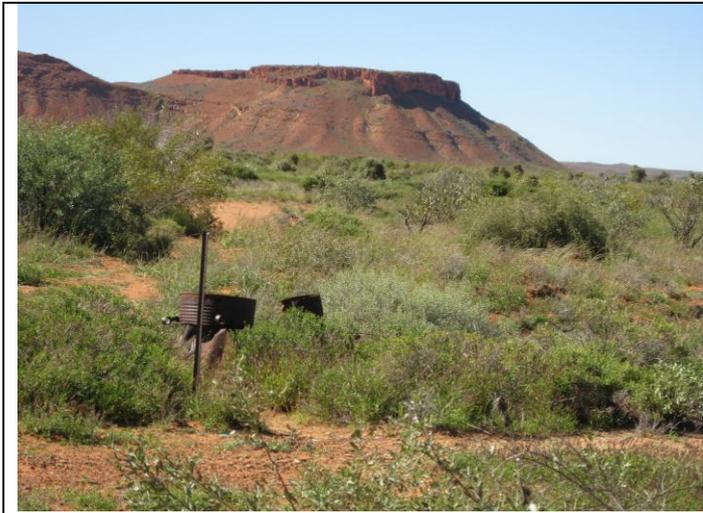
NM/F/210 Crown Head from Well 48 (Courtesy L.McLean)

- **Crown Head** on the morning of Wednesday 11 August 2010, a stone cairn, centre pole and beacon vanes were observed on this topographical feature; scaled coordinates of which are: 20 degrees 15.5 minutes South 126 degrees 32.4 minutes East. **Map sheet used:** 1:250,000 NTMS: SF52-01 Cornish, Edition 2. **Station Condition:** While the observation point was on the plain below the topographical feature, structural elements of the station appeared in good order ie stone cairn, vanes and centre pole.

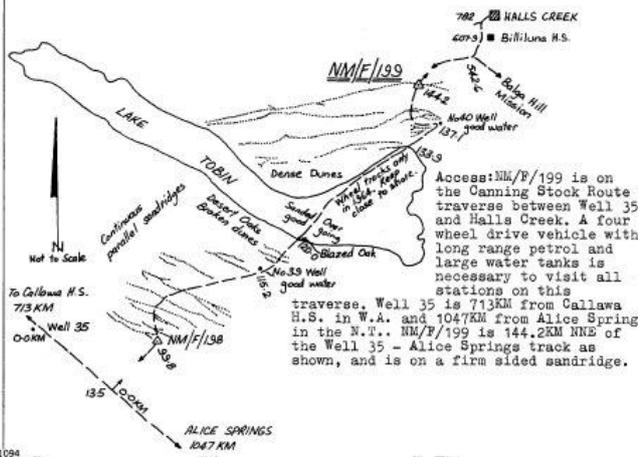
Station Number and Name: NM/F/199

Access and Locality Sketch: Particulars of station marking and beacon:
Station Mark: 1.3cm copper tube cemented into top of 1.5m length of pipe buried in ground with concrete block at top.
Beacon: 3.35m x 5cm x 5cm G.I. pole with four 0.91m x 0.53m G.I. vanes set 14cm below top of measuring spike which protrudes 6cm above top of pole. The beacon is braced by four 3.05m lengths of "Rokangle".
Reference Mark: A 1.5m length of angle iron driven into the sandridge.
Recovery Mark: A recovery mark (Point B illustrated) and two base terminals (points A and C) were set out on a flat between sandridges. Points A and C are steel fence posts driven into the ground and protruding approximately 15cm. Point B is a 1.5m length of 4cm diameter water pipe protruding about 2cm above ground level, with a concrete block around the top of the pipe. Two circular trenches were dug concentrically around this recovery mark, and the spoil was piled in a mound between the trenches. A large bush tripod, painted white, was erected over recovery mark.
