**MACQUARIE ISLAND  
SURVEY PROGRAM**

**FIELD WORK REPORT**

**VOYAGE 3 ROUND TRIP  
NOVEMBER/DECEMBER 1996**

Prepared by Richard Lemon for  
the Australian Antarctic Division  
January 1997

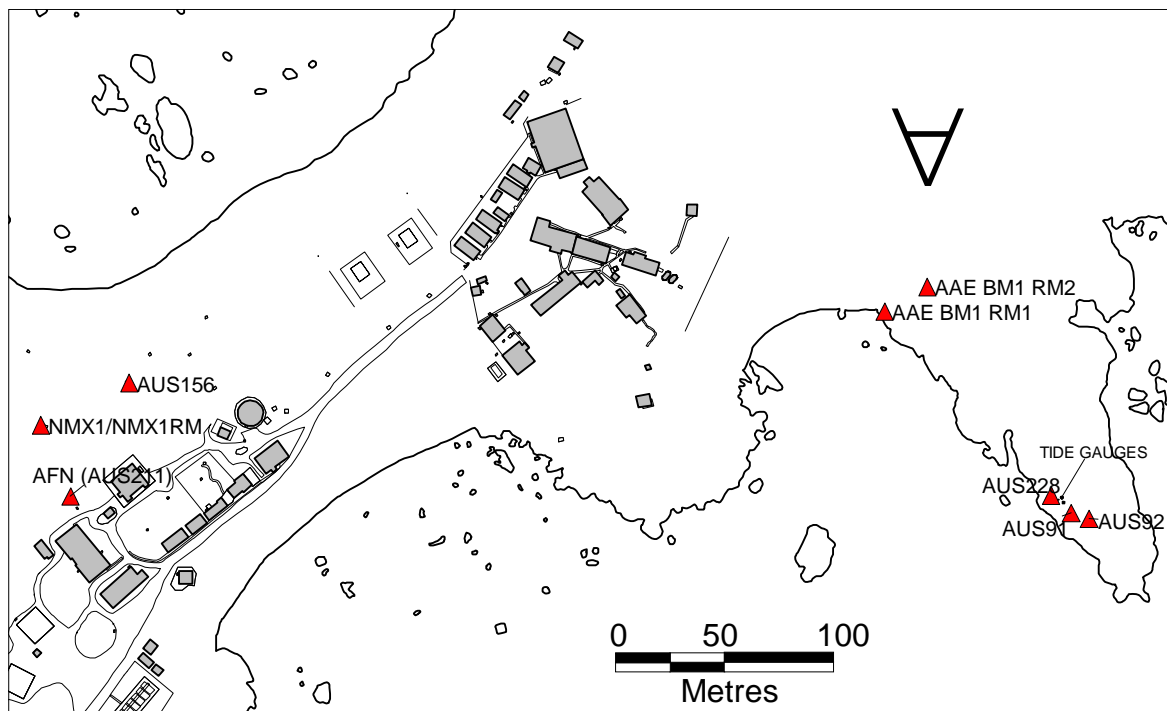
Diagram showing location of survey marks included in the precise levelling

A precise levelling run was made from the AFN Station AUS211 RM2 to the Garden cove tide gauge benchmark AUS228 using an NA2000 digital level. The following stations were included in the levelling run:

NMX1	Steel top of Aurora Camera Stand
NMX1 RM1	Stainless steel bolt grouted in base of Aurora Camera Stand
AUS156	Holding down bolt on anemometer tower
AAE BM1 RM1	Stainless steel bolt grouted in rock
AAE BM1 RM2	Stainless steel bolt grouted in rock

Levels were also measured from AUS228 to AUS91, AUS92, the Aquatrak tide gauge rim and the Druck tide gauge rim. The height differences from the tide gauge rims to the tide gauge reference marks were also measured using a small spirit level and steel ruler.

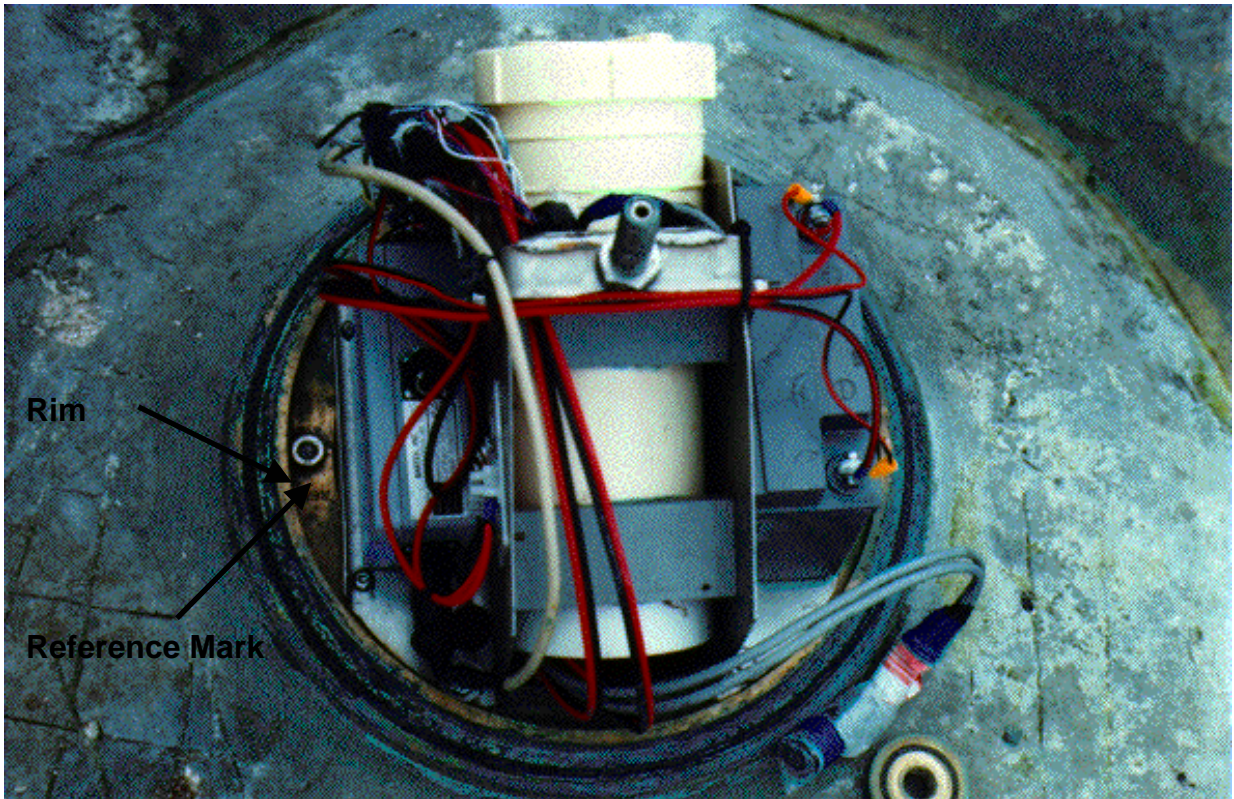
AQUATRAK Tide Gauge - rim and reference mark

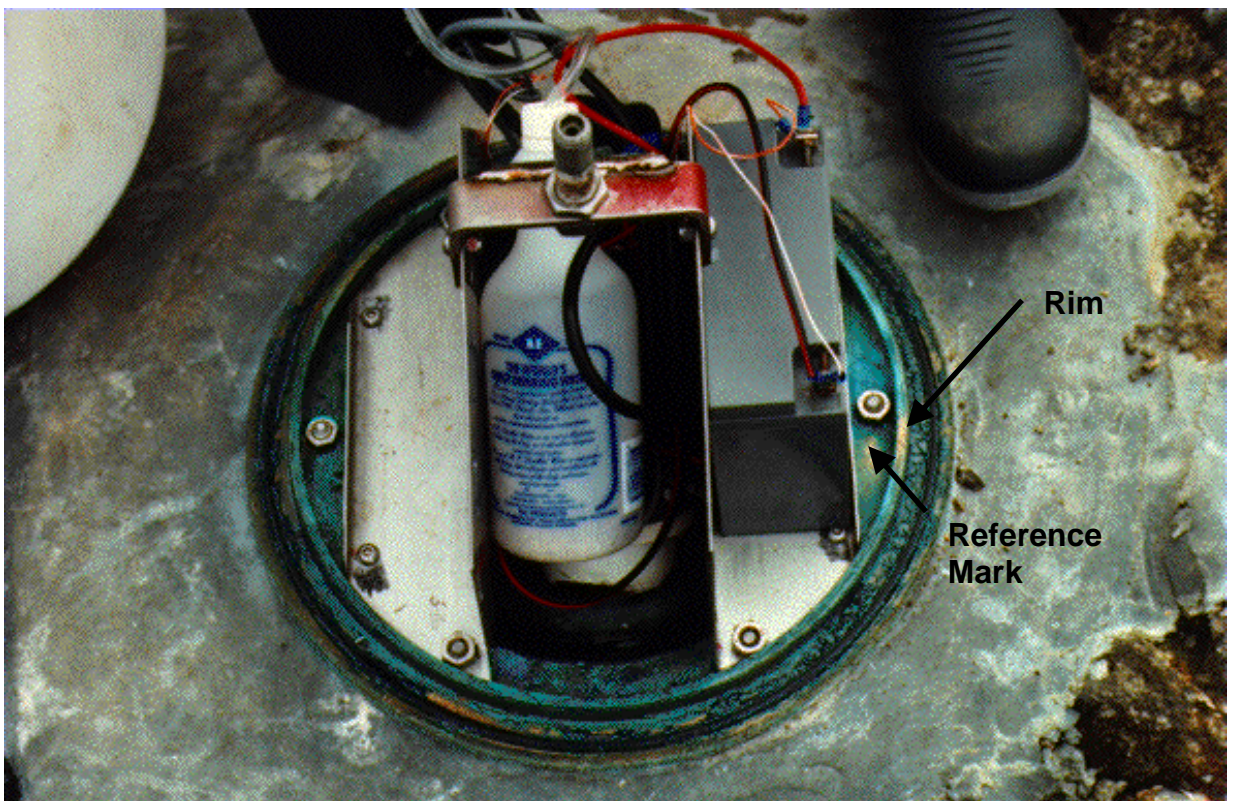
Druck Tide Gauge - rim and reference mark

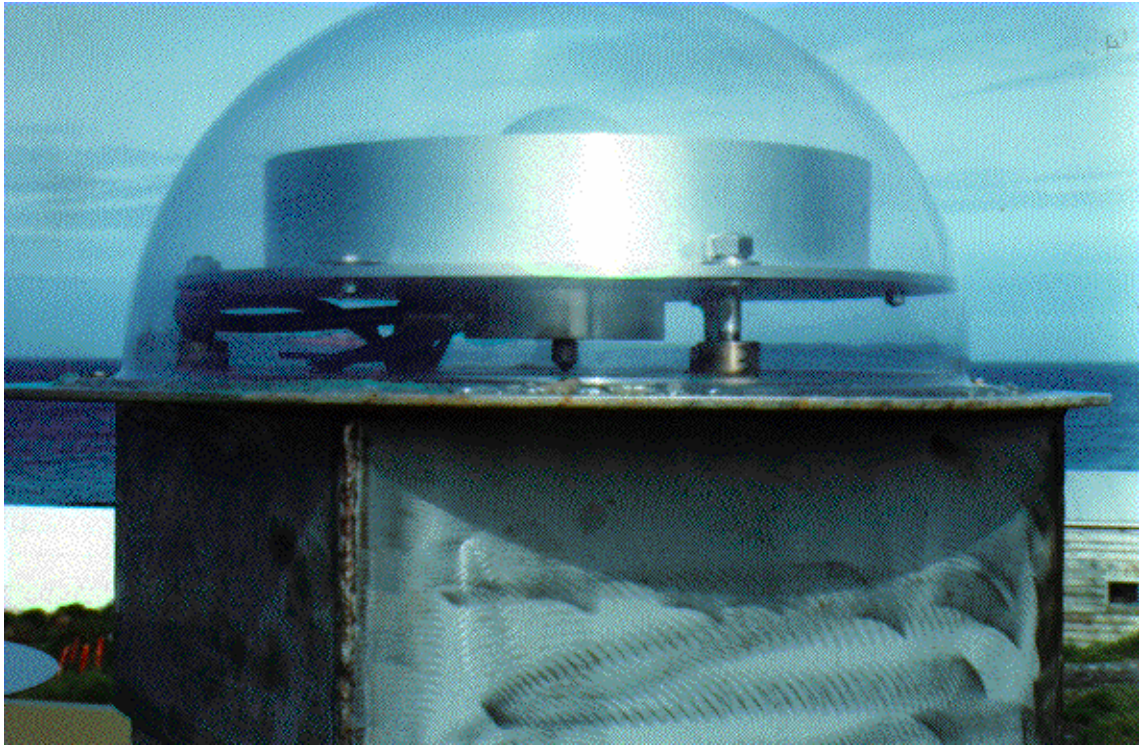
AFN (AUS211) Weather proof perspex dome

In addition to the above, the height relationship between AUS211 RM1 and AUS211 RM2 was measured. This involved the removal of the weather proof perspex dome from the AFN GPS antenna. The dome was replaced and resealed on completion of this task.

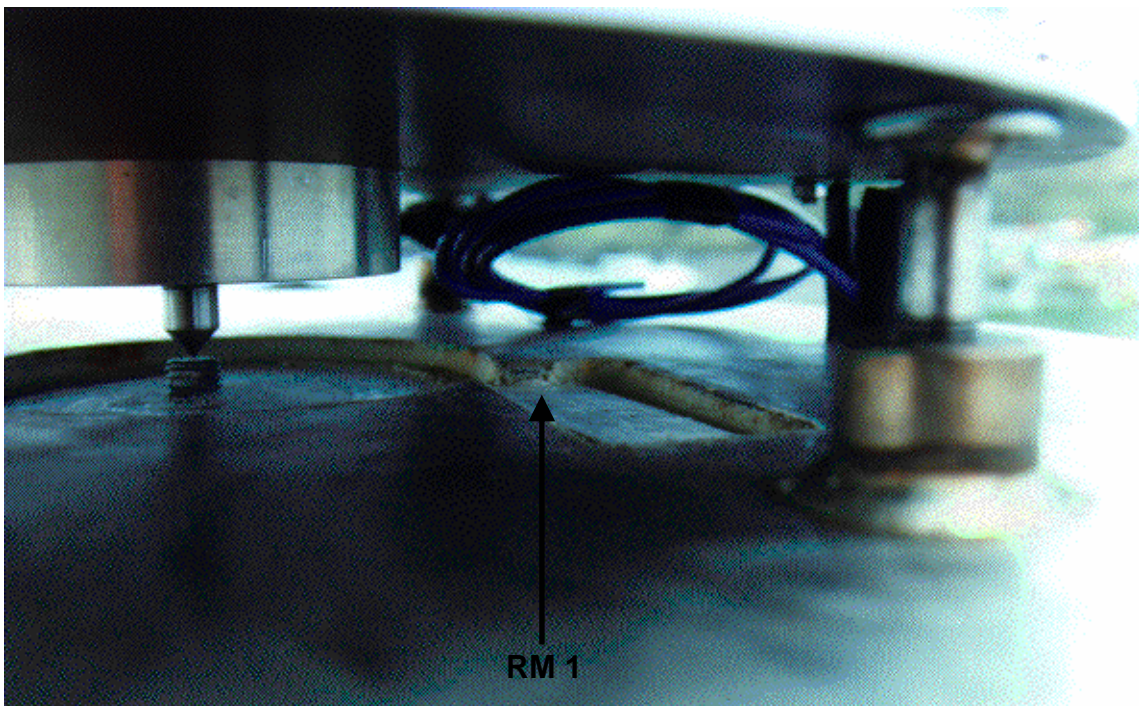
AUS211 RM1

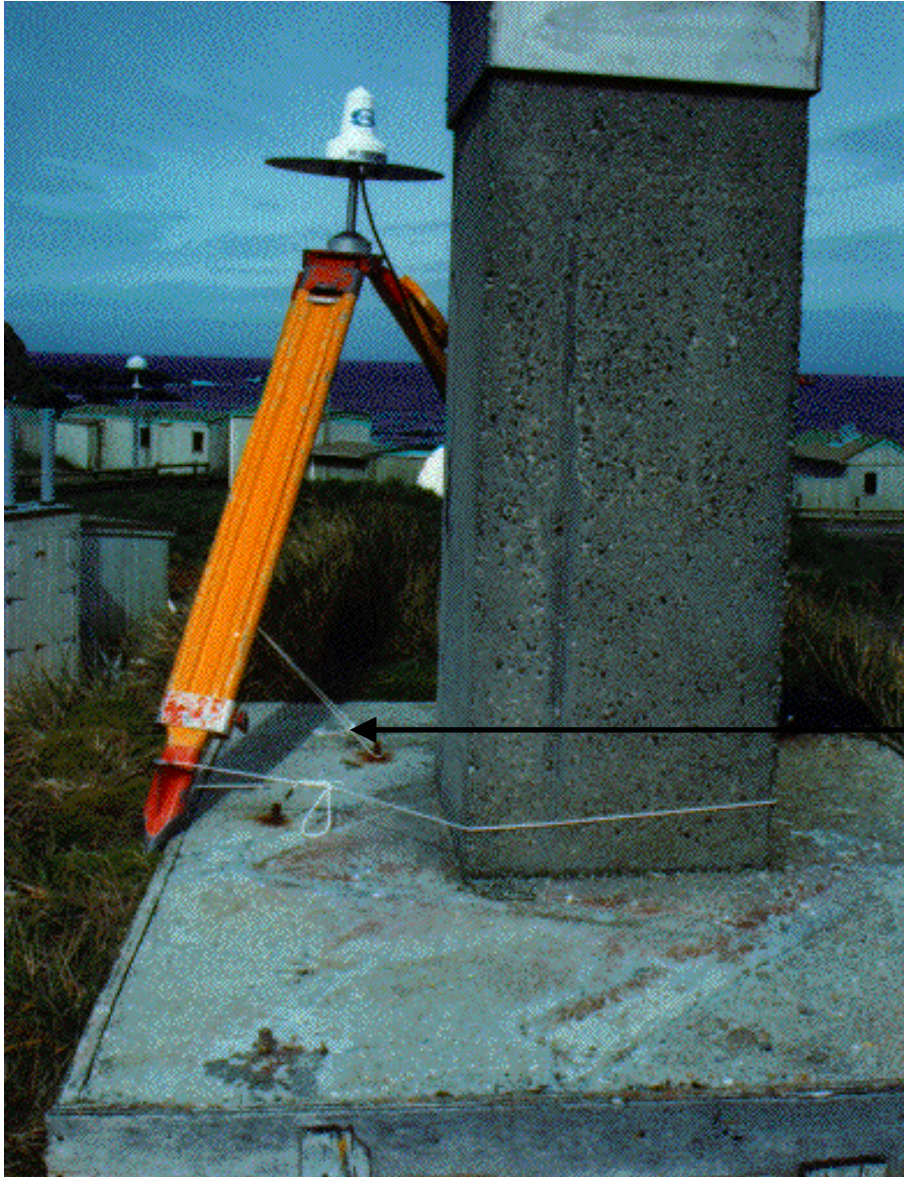
RM 2

AUS211 RM2

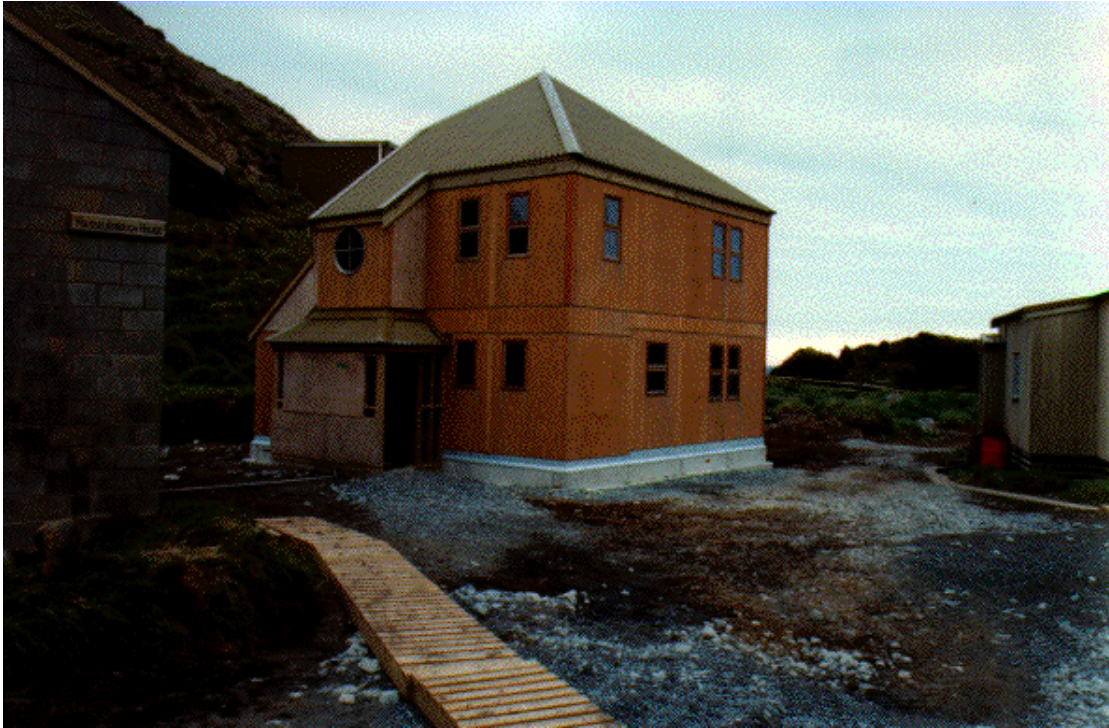
The station facilities were checked for new and demolished buildings. There was one new building, 'Cumpston Cottage', this was surveyed and located with respect to the existing buildings.

Cumpston Cottage

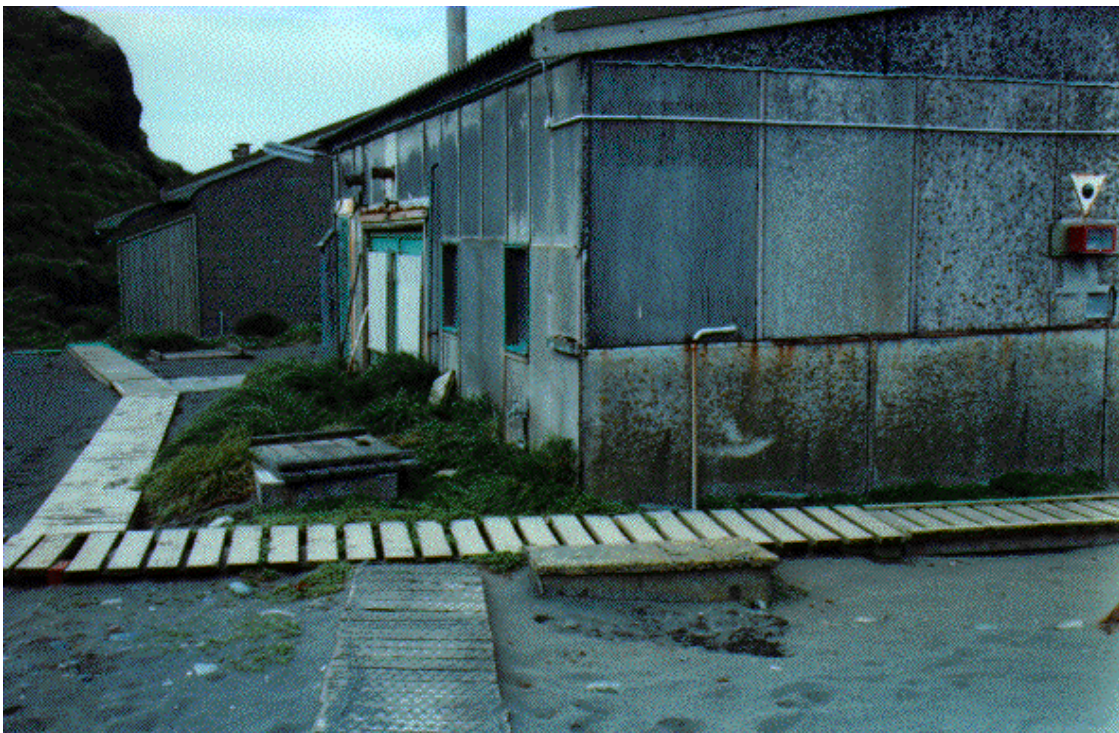
Service pits were also located by offsets from buildings and their sizes and orientations measured. Some features, including antenna guys and communication pits, outside the main station area were surveyed using Kinematic GPS. All survey information has been supplied to AUSLIG's Canberra office to enable updating of the Antarctic Division's Station Database.

Service Pits - near Emergency Power House

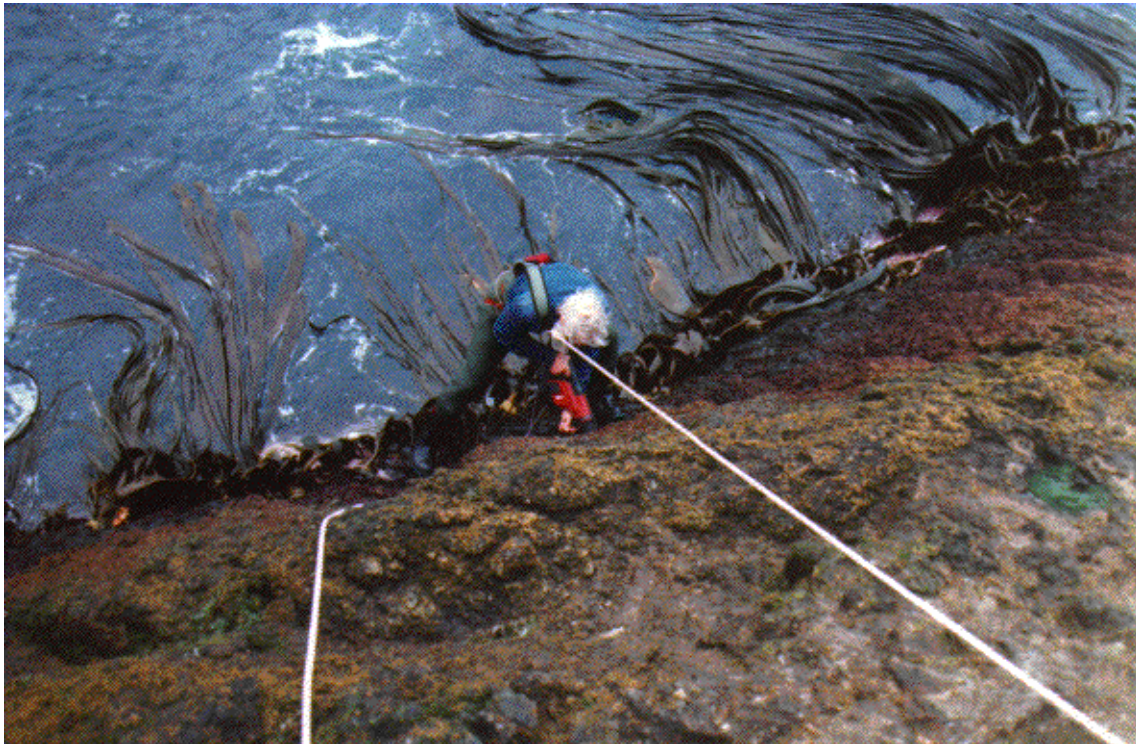
A tide staff was suspended from a fixture bolted to the sea wall face at Garden Cove in a swell which made drilling the holes and assembling the fixture difficult.

Roger Handsworth drilling bolt holes for tide staff in difficult conditions

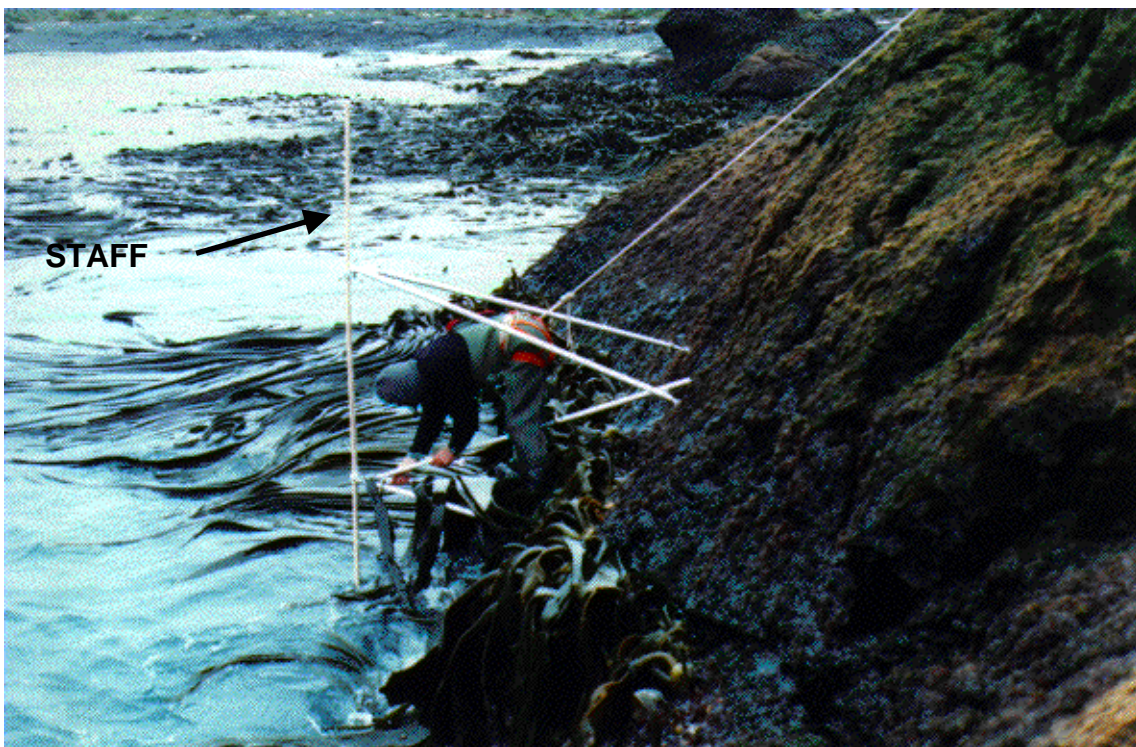
Roger Handsworth checking the fixture after installation

The swell was too great to be able to take meaningful water level readings from the staff. The staff and fixture have been left in place in the hope that it will survive the seas for long enough for readings to be taken in a flat sea by station personnel.

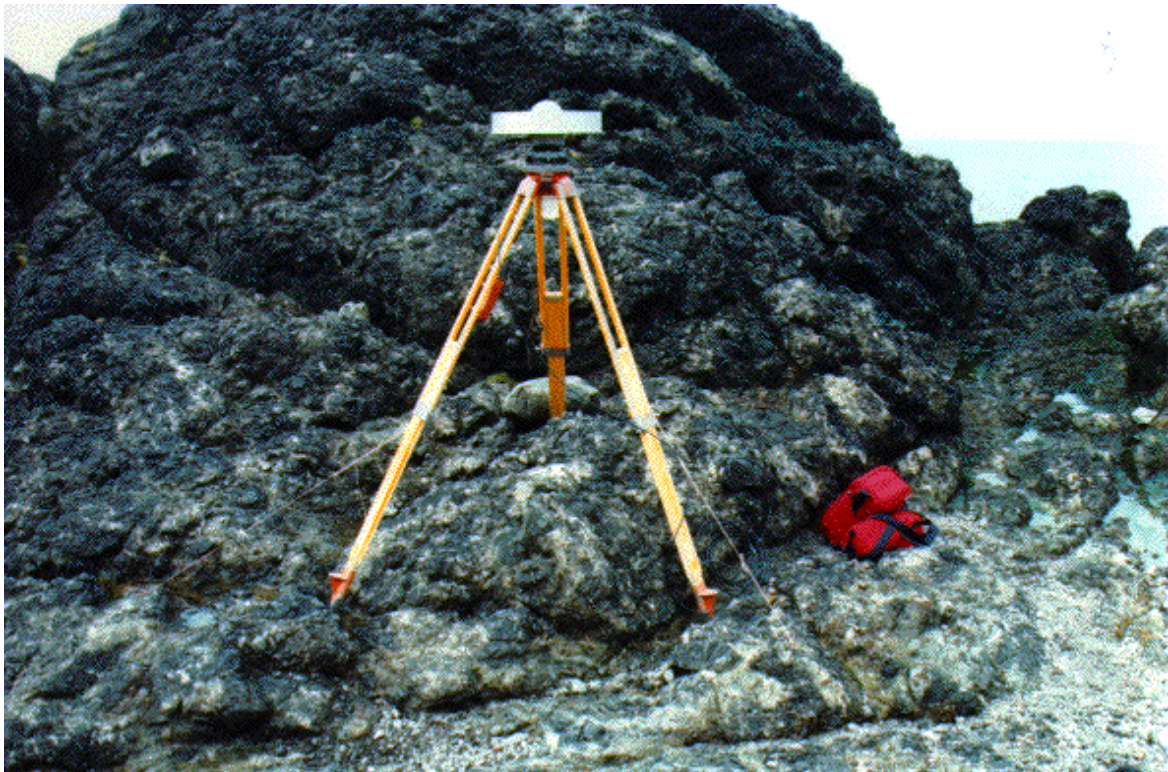
An Ashtech Z12 GPS receiver equipped with a Dorne Margolin T antenna was used at AUS92 (a bench mark at the Garden Cove tide gauges). This antenna being the same as the one used at the AFN station. The equipment was centred over AUS92 using a tripod and tribrach and tied in place. Twenty hours of GPS data was collected at AUS92 before being notified that the AFN GPS system was not logging data. The Rogue GPS receiver was disconnected from the AFN antenna and another Ashtech Z12 GPS receiver was connected. Twenty four hours of common data was collected at the AFN and AUS92.

GPS receiver set up on AUS92

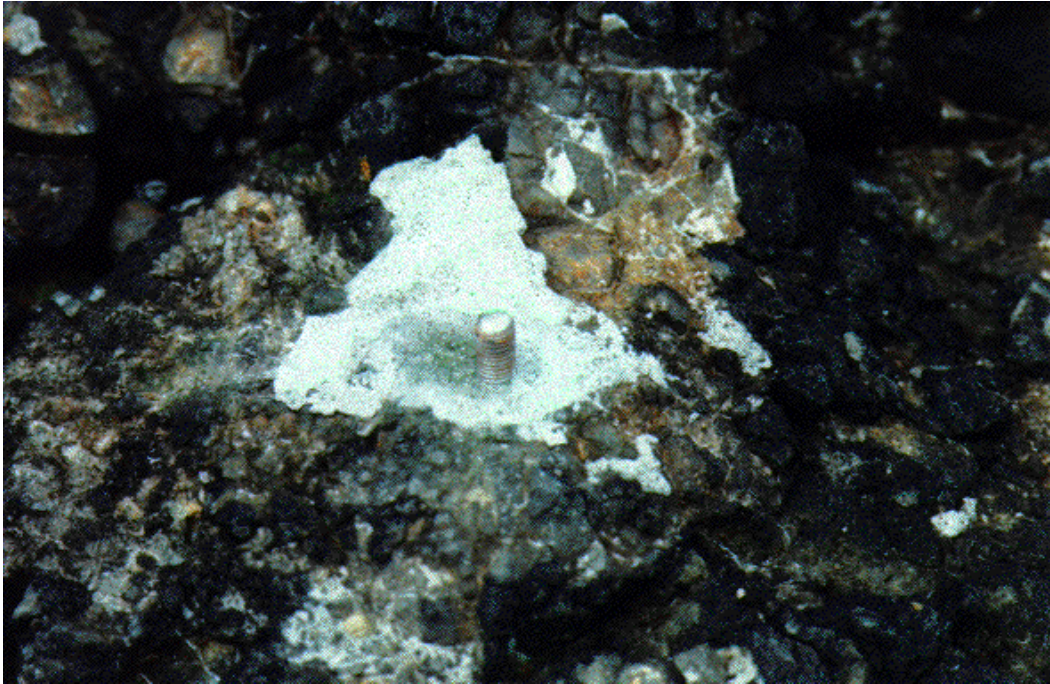
AUS92 was found to be missing its identification tag.

AUS92 - missing its identification tag
